New York State Department of Transportation

Yellow Flag NB2228W005

BIN: 1065318

Location: Span 190, Girder G1 at Pier 190.

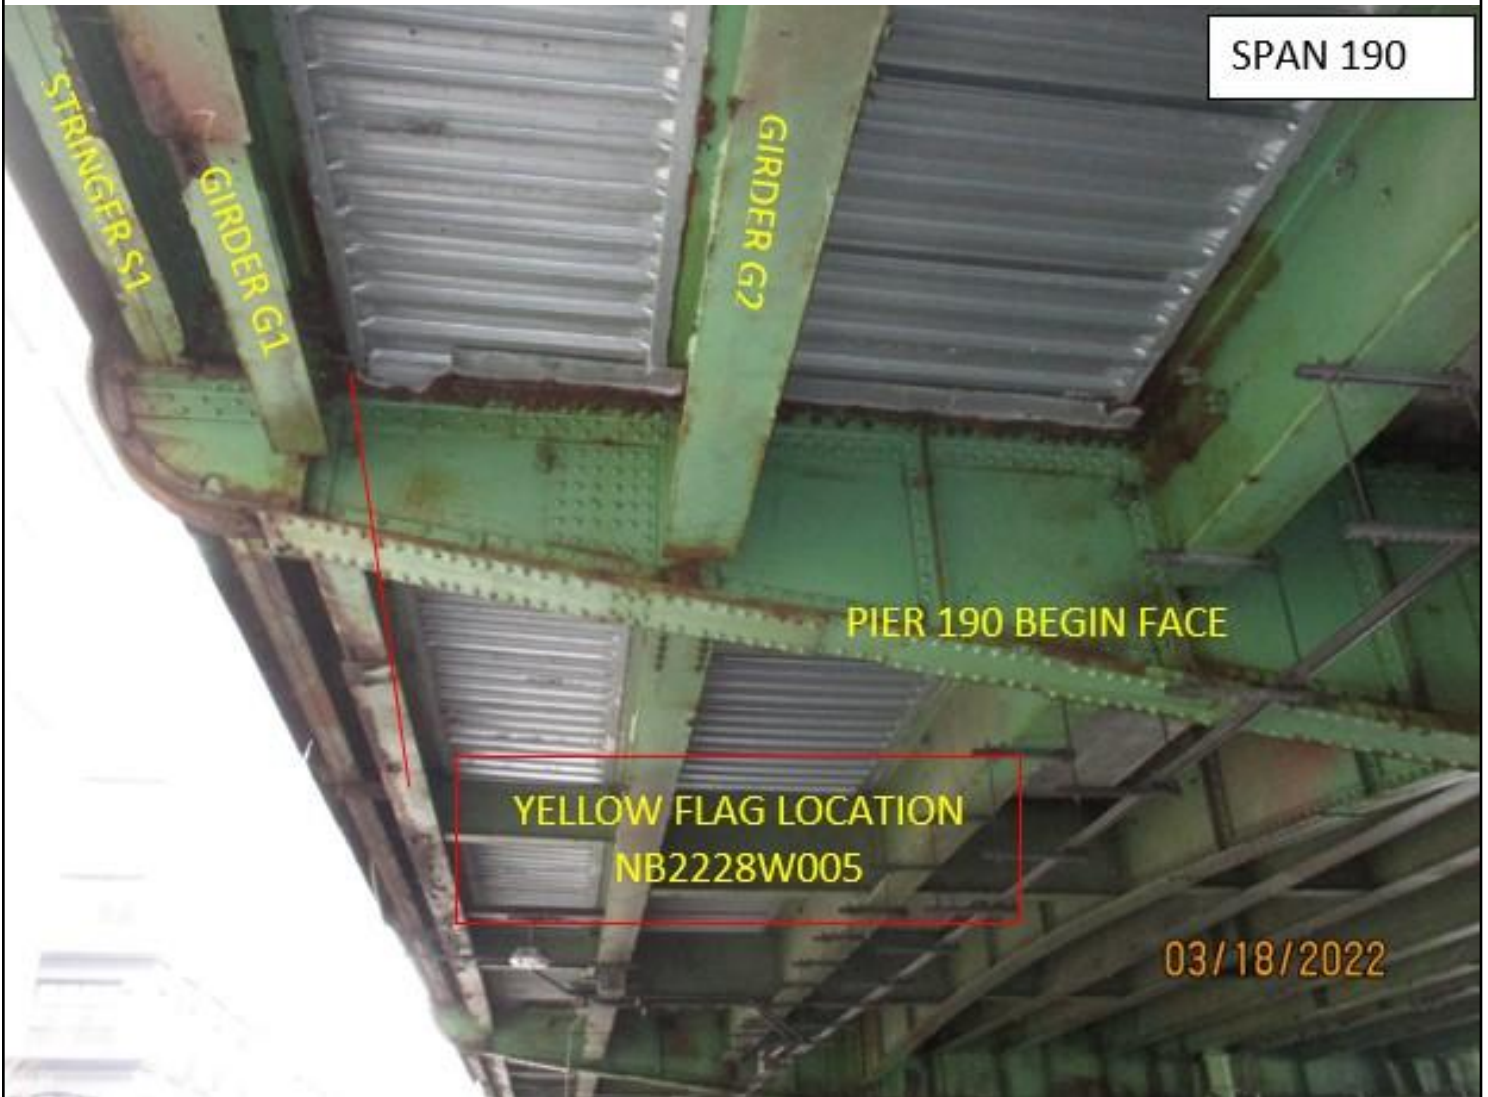
Photo Number: 1

Attachment Description: Span 190, Girder G1 at Pier 190. General view of flagged location at pier cap. Looking end.

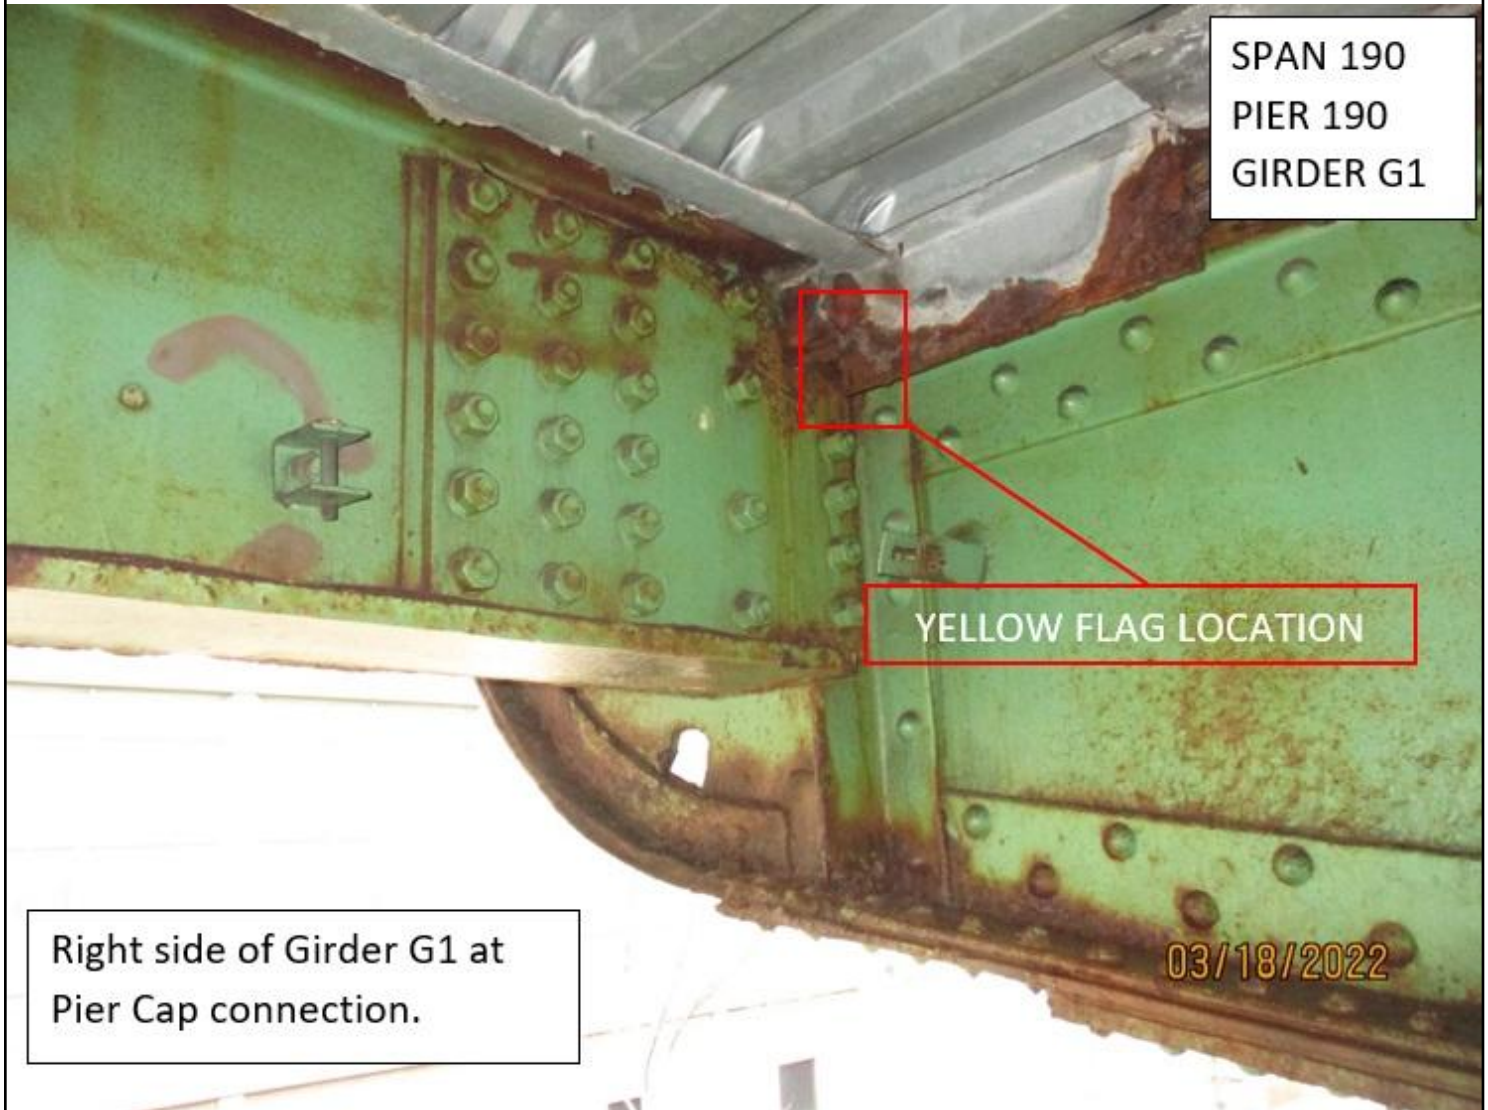
Photo Number: 2

Description: The left clip/connection angle of Girder G1 connection to the pier cap at Pier 190 exhibits a 5" long vertical crack x 1/2" wide at the upper fillet section (deterioration induced cracking, no change from the previous). At the right side of G1, the stiffener/connection angle has a 3" long vertical crack x 1/4" wide (deterioration induced cracking, previously noted to be 2.75" long x 1/4" wide) also at the upper fillet section.

Attachment Description: Span 190, Girder G1 at Pier 190. General view of 3" L x ¼" wide corrosion crack at upper fillet of stiffener connection angle at right side of girder connection to pier cap. Looking end left.

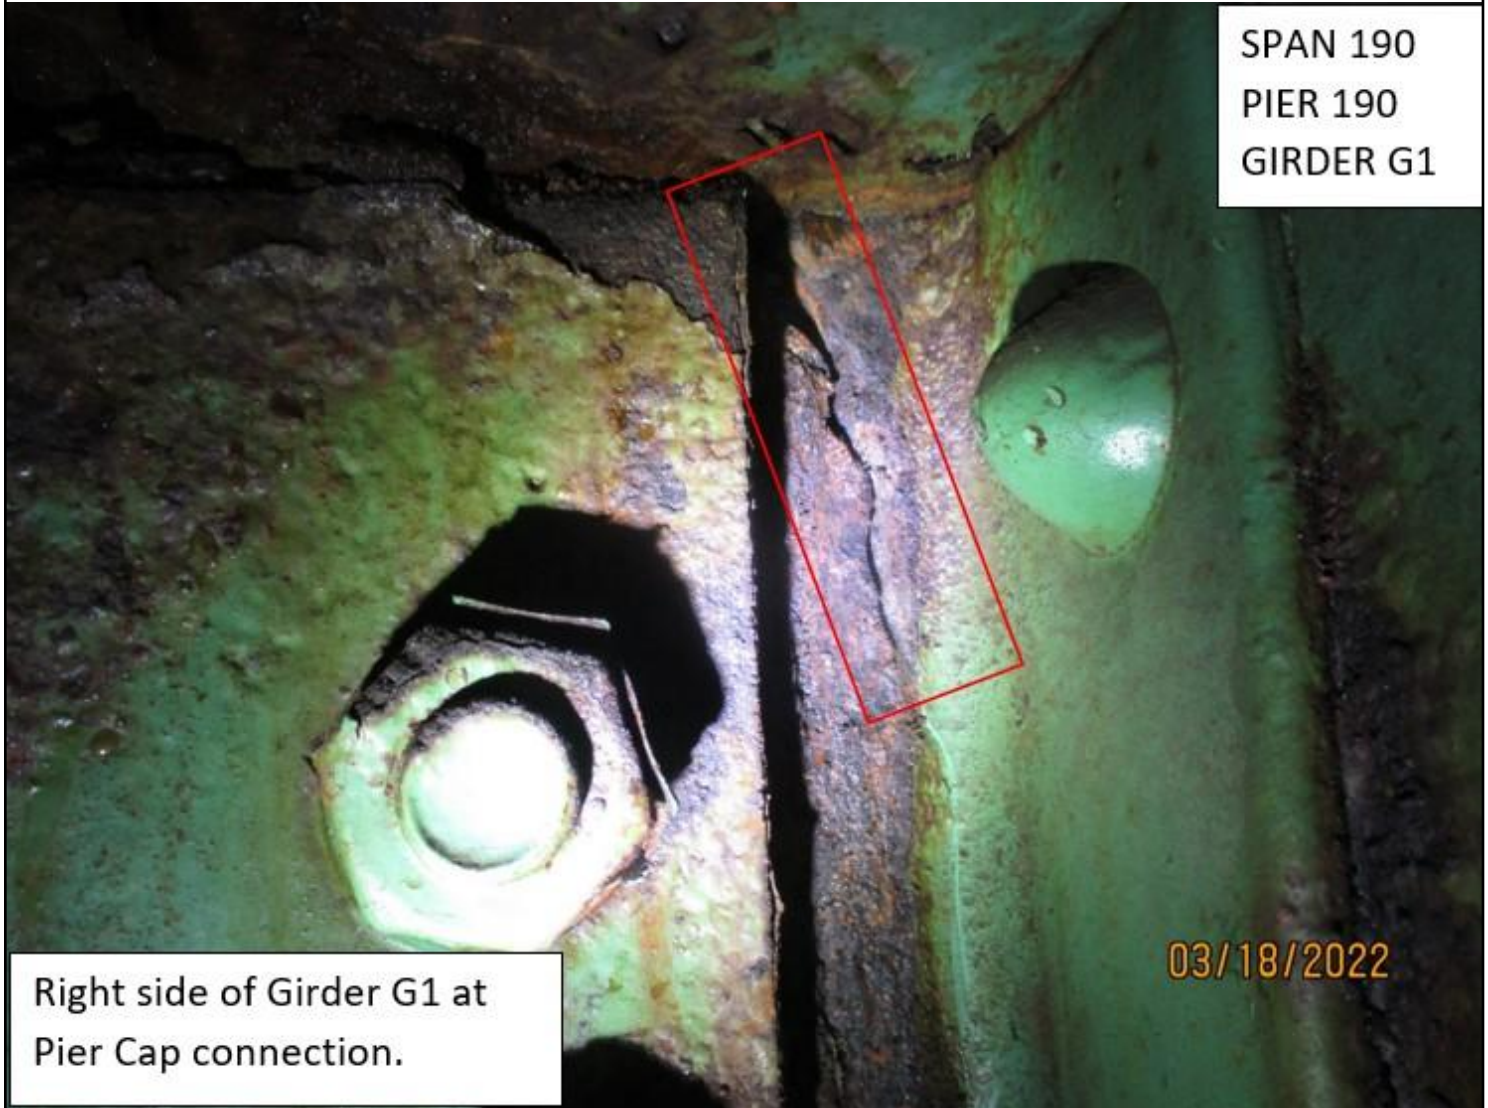
Photo Number: 3

Attachment Description: Span 190, Girder G1 at Pier 190. Close up view of 3" L x 1/4" wide corrosion crack at upper fillet of stiffener connection angle at right side of girder connection to pier cap. Looking left.

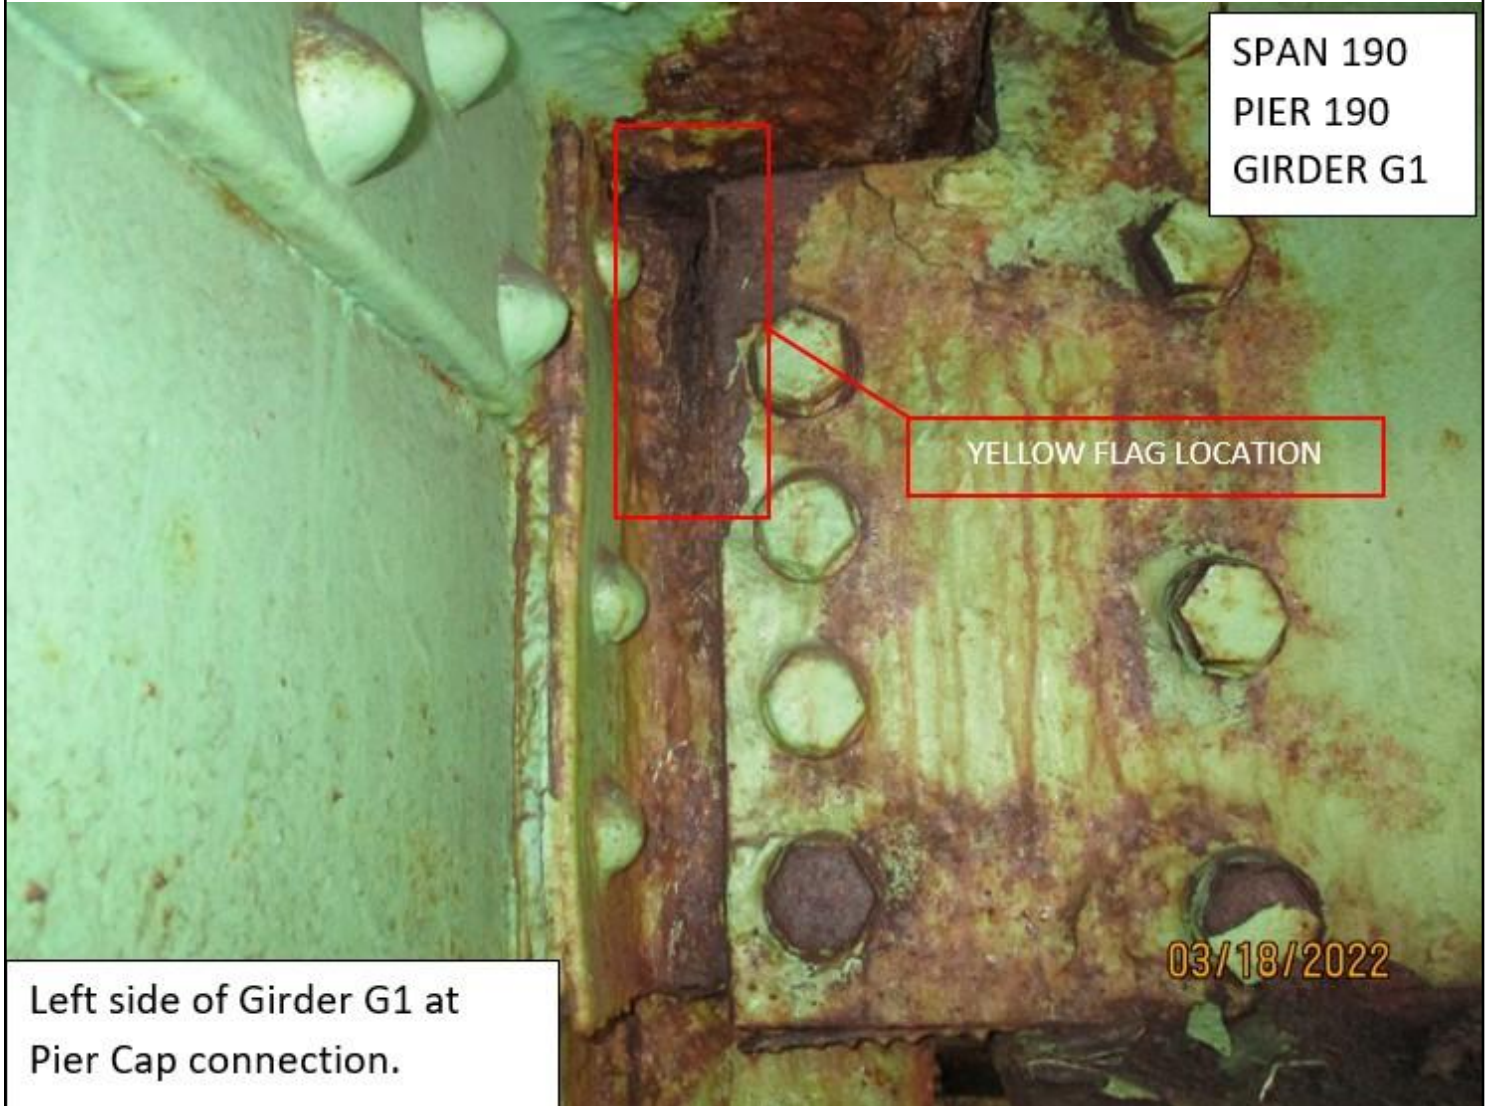
Photo Number: 4

Attachment Description: Span 190, Girder G1 at Pier 190. General view of 5" long x ½" wide corrosion crack at upper fillet of clip connection angle at left side of girder at pier cap connection. Looking right.

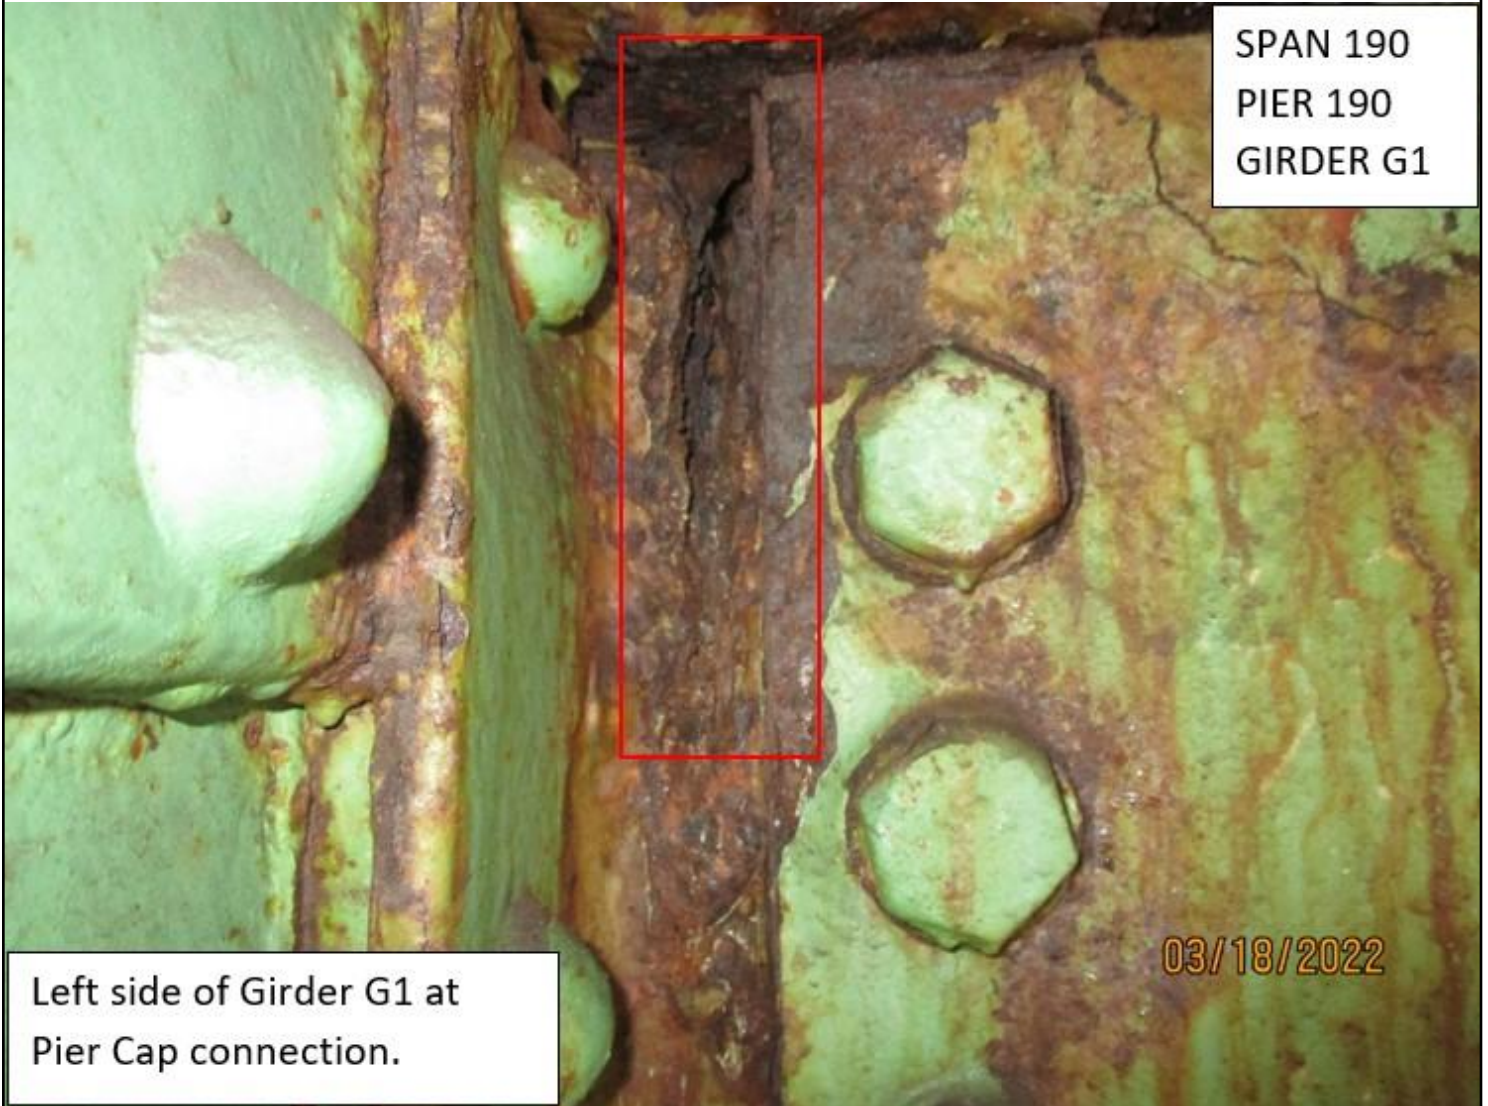
Photo Number: 5

Attachment Description: Span 190, Girder G1 at Pier 190. Close up view of 5" long x ½" wide corrosion crack at upper fillet of clip connection angle at left side of girder at pier cap connection. Looking right.

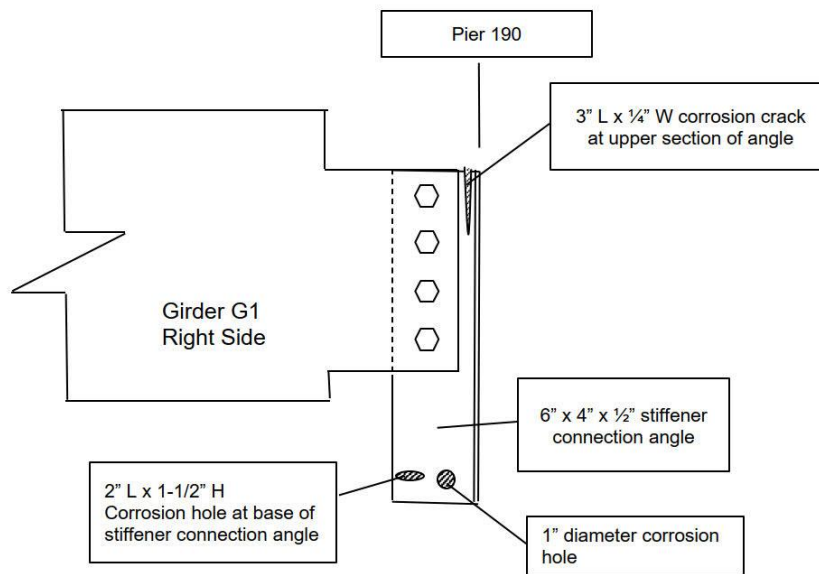
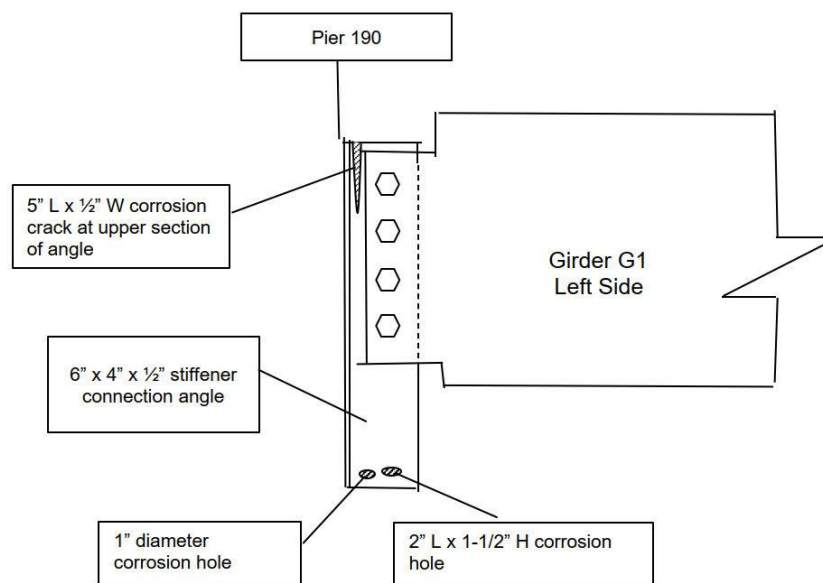
**SPAN 190, GIRDER G1 BEAM END AT PIER 190**

Attachment Description: YFNB2228W005, Sketch Form for Girder 1, Span 190
